# BELZONA ELASTOMER REPAIRS A FRANCIS TURBINE

ID: 8199

Mechanical damage of Francis turbine blades due to strong cavitation.

Damaged Francis Turbine

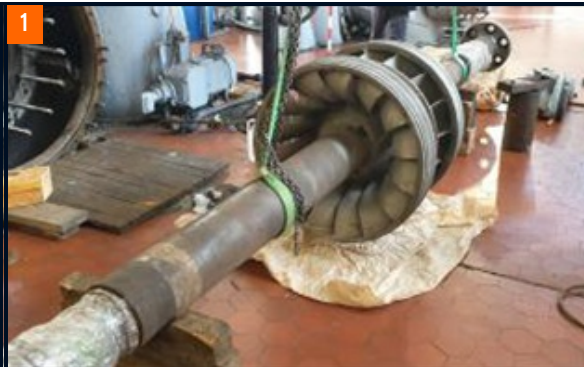
1. Francis turbine rotor after grit blasting
2. Reprofiled with Belzona 1221
3. Application of Belzona 2141
4. Completed Application

Abrasive grit blasting. Dedusting and degreasing the surface with Belzona 9121. Reprofilling cavities with Belzona paste 1221 Applicationg Belzona 2941 and then Belzona elastomer application 2141 in a system of two layers. In line with Belzona Know-How System Leaflet CEP-3.
