# BELZONA SEALS OPEN DRAIN

ID: 820

## PROBLEM

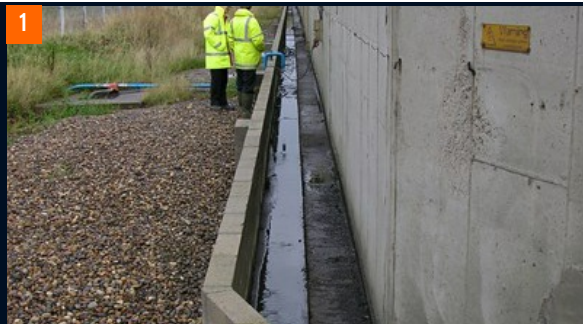
Under heavy rain the drain leaks through the concrete base/block interface & through the porous blocks themselves.

1. General view of open drain
2. Belzona 5811, first coat
3. Belzona 5811, second coat
4. The completed application

The application was carried out in accordance with Belzona Know-How System Leaflet TCC-15. The drain was pressure washed to remove any dirt & contaminants and allowed to dry. A fillet of Belzona® 4131 was formed along the base/wall interface followed by two coats of Belzona® 5811.
