# DAIRY FARM WASH STATION PROTECTED WITH BELZONA 4181

ID: 8202

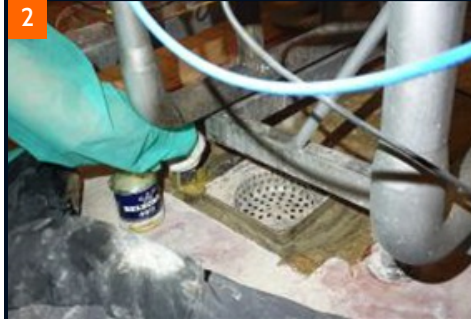
Unsealing of the joints in the dairy plant wash station causes floor destruction.

The floor in a wash station of a dairy plant had a number of issues due to the unsealing of joints.

1. Damaged chemically resistant floors
2. Belzona 4111 around the drain.
3. Application of Belzona 4181
4. Complete Application

The Application was completed in accordance with Belzona System Leaflet FPA-01. Removal of damaged concrete and leveling the pump work area. Belzona 4111 applied around the damaged drain area. Belzona 4181 used to provide a chemically resistance to the floor area then post cured by heating the Belzona 4181 for 4 hours.
