# PAPER & PULP PLANT TANK REPAIRED WITH BELZONA 5892

ID: 8203

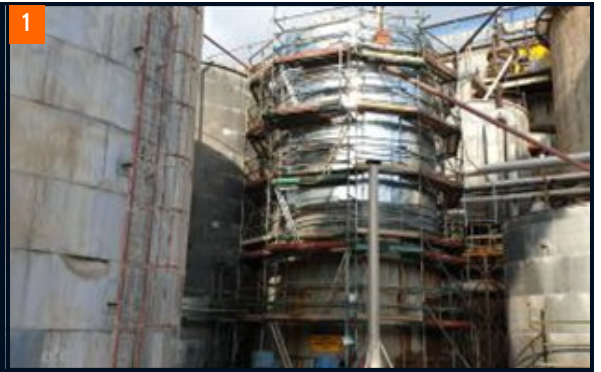
Internal of the condensate tank at the paper & pulp plant was suffering from corrosion.

Condensation Tank Application of Belzona 5892  
Belzona 5892 2nd layer  
Application Complete

Substrate grit blasted to surface cleanliness (Sa21/2). Followed a profile check for the min surface roughness of 75 microns. Degreasing surfaces with Belzona degreaser 9121 and applied Belzona 5892 in a two coat system. The application was completed in accordance with Belzona System Leaflet TCC-05.
