# BELZONA REPAIR TO CORRODED PROPELLER SHAFTS

ID: 8204

Two propeller shafts on heavy utility vessel, 6.5m long and 100mm in diameter. Constantly submersed in sea water.

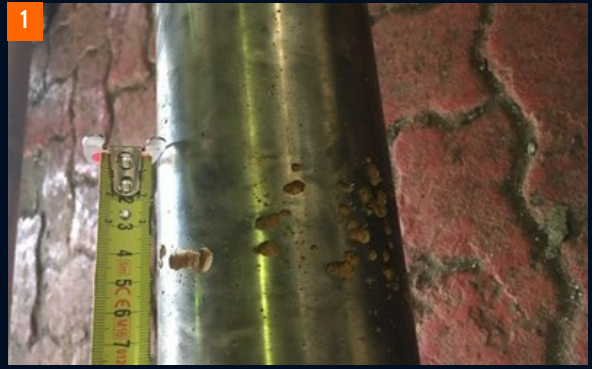
Two propeller shafts on a port utility vessel were badly corroded from bimetallic corrosion and eroded due to wear from gland packing. If left untreated, significant structural damage would occur and replacement would be imminent. The cost of replacement is prohibitive, as well as down time required.

1. Damaged shafts showing corrosion damage 2. Grit blasted and machined shaft 3. Undercut rebuilt with Belzona 1111, ready for final machining. 4. Completed shafts, ready for fitment.
