# BELZONA SOLVES HOLED TANK & HANDRAIL PROBLEM

ID: 821

Holed chemical tank & corroded handrail support.

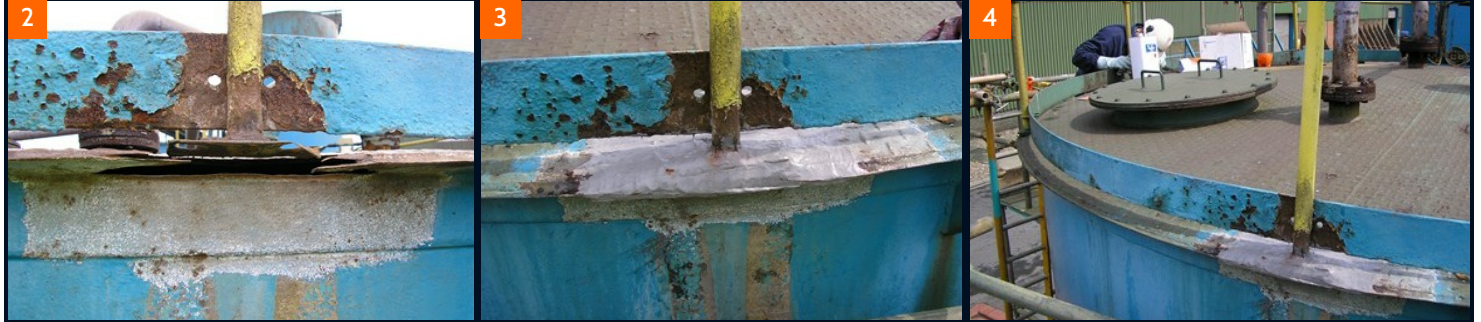
General corrosion on this old chemical tank had left a hole at the top under a handrail support.

1. View of corroded area.
2. Surface preparation ongoing.
3. Rebuilding with Belzona 1111.
4. The completed repair.

The application was carried out in accordance with a modified version of Belzona Know-How System Leaflet TCC-5. After a preparation involving needle-gunning & abrading a support plate was bonded onto the underside of the repair area using Belzona® 1111. Once this had cured the whole area was then rebuilt using Belzona® 1111 incorporating reinforcing sheet.
