# BELZONA PROVIDES EXTERNAL CORROSION PROTECTION FOR LNG TERMINAL PIPELINES

ID: 8221

Taiwan LNG Terminal

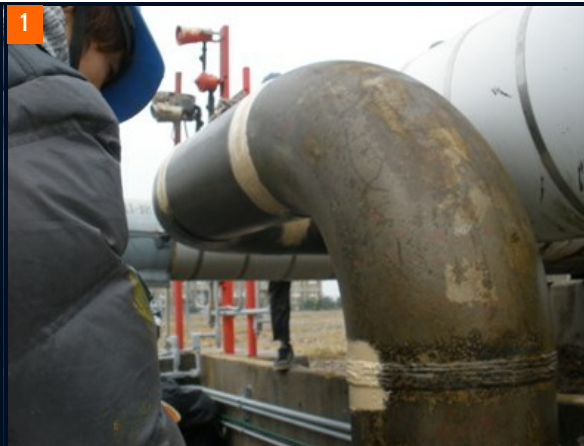
Condensation has caused premature failure of the original coating on LNG pipelines. Meanwhile, condensation is continuously generating in the pipeline so that traditional corrosion protection coating unable to apply.

1. Corroded pipelines 2. Surface preparation with high-pressure water 3. Apply Belzona 5831 on-site 4. Application complete
