# BELZONA MODIFIES FLANGES

ID: 8229

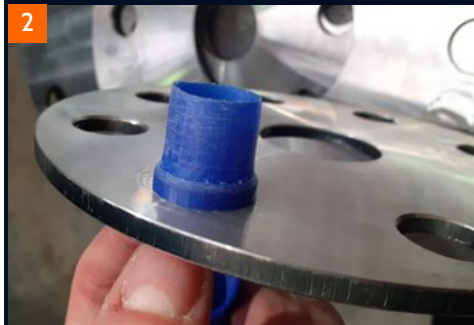
1. Shot of Vessel 2. Collars within former 3. Repaired flange with nozzle insert 4. Final View of repaired flanges

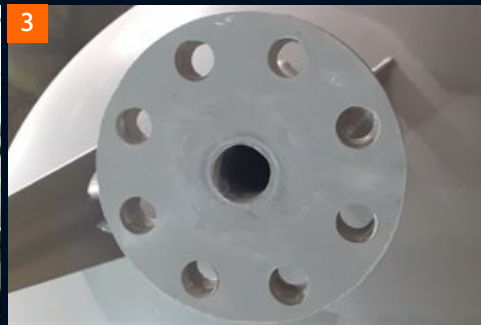
The standard flange face formers could not be used so a brand new technique was created using a series of 3D printed collars that fit within the bolt holes and gave shimming of 5mm so the Belzona would cover the RF of various sizes 2, 4, 8 inch.

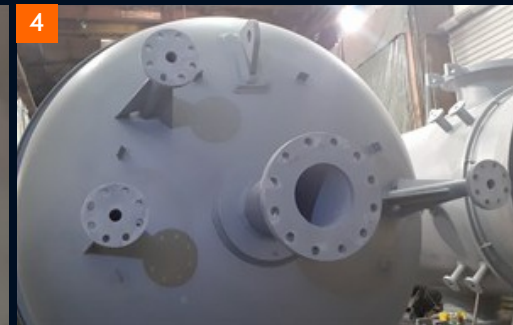
Vessel required flanges to be modified to accept pipe connections when delivered to site. Due to an error at the manufacturing and design stage, raised face (RF) flanges were incorrectly welded onto the pipe inlets and outlets, these required to be flat face (FF) flanges.

The repair was completed with a modified version of Belzona system Leaflet GSS-06 using steel formers and 3D printed collars.
