# BELZONA TANK BASE SEALING PREVENTS STRESS CORROSION CRACKING

ID: 823

Stainless steel storage tank base seal

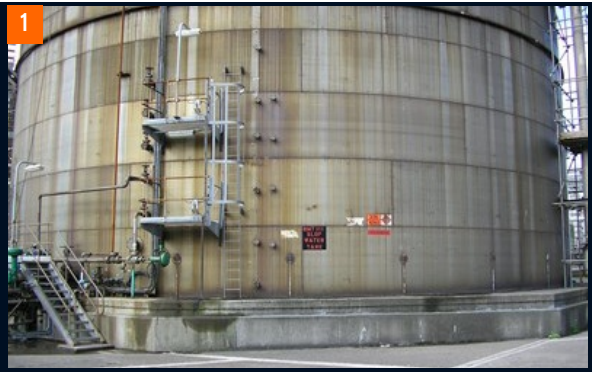
1. General view of Stainless Steel tank
2. Close up of base prior to fitting the system
3. Close up of the applied System
4. Tank Base sealing Systems side by side

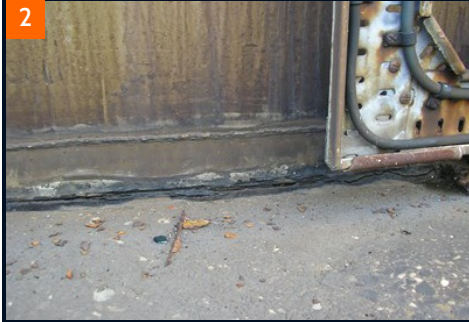
Materials engineers on-site had highlighted that a stress corrosion cracking environment could be created if water was allowed to ingress under the tank floor.
