# BELZONA PROVIDES INTERNAL CORROSION PROTECTION FOR GRAVITY SEPARATORS

ID: 8232

Natural gas plant raw material gravity separator.

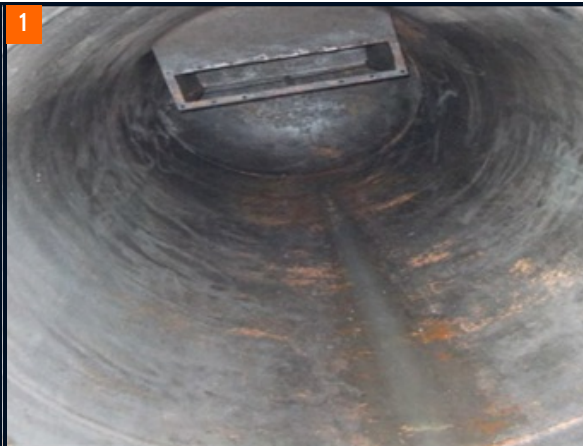
The base and top of the separator have been subjected to erosion and corrosion for a long time, and a large amount of pitting corrosion has emerged.

1. Separator inner wall before application
2. Inner coating completed
3. Coating integrity reviewed in 2010
4. Coating thickness reviewed in 2015

Application carried out in accordance with Belzona Know-How System Leaflet TCC-5. Belzona 1111 to repair the pitting defects and then apply Belzona 1321 to complete the application.
