# BELZONA PROTECTS INNER TUBES OF TUBULAR CONVEYORS IN WOOD PLANT

ID: 8234

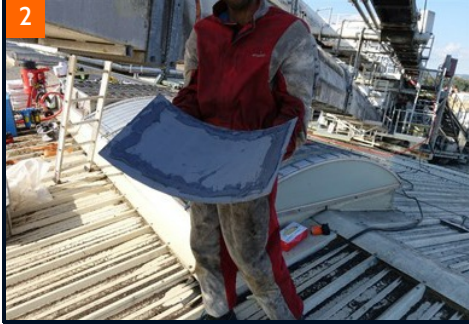
In the lower third, in which the belt slides on the steel tube, the two tubes of the tubular conveyor were partially so worn that large holes were created. This not only damaged the structure of the pipe, but also allowed the air film to escape, which should be present as a sliding film between the steel pipe and the conveyor belt. The pipeline is over 100 m long. Accessibility, especially in the lower tube, is extremely difficult.

1. Box construction partially cut open so that the damaged areas were also accessible from the outside.
2. At the points with larger holes, a reinforcement plate was first glued on from the outside. Belzona 1212 applied on the blasted reinforcement plate.
3. Reinforcement plate positioned
4. Finished repair point in the lower tube

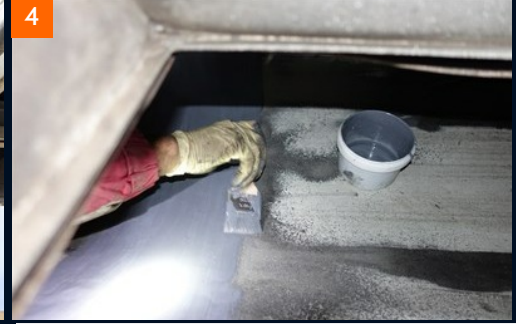
Completed repair at the beginning of the pipeline. The Belzona product in this area extends beyond the steel level as the steel will wear out relatively quickly. It was agreed that additional rollers would be installed that would protect this area from the massive abrasion load.
