# BELZONA COATS A HYDRO POWER PUMP SHAFT

ID: 8235

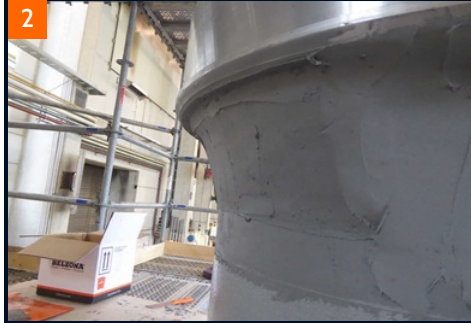
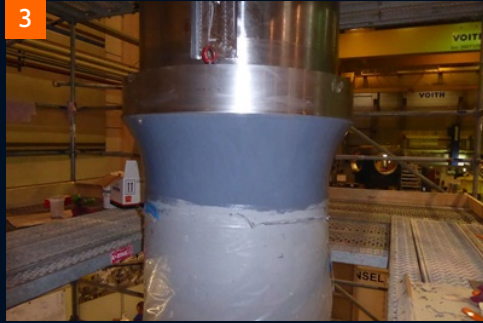
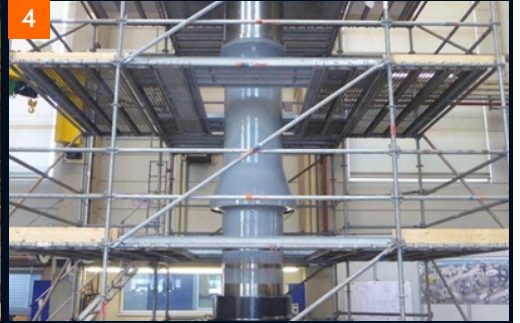
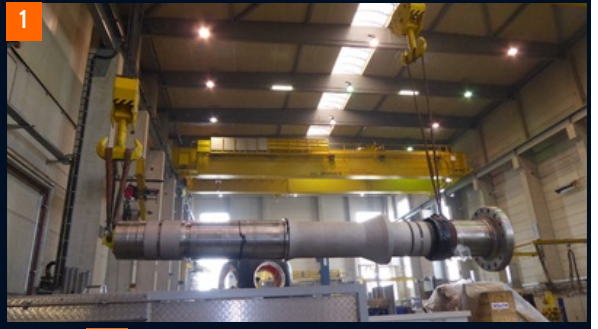
Conditions during operation: Head: 760 m, Power: 195 MW, Speed: 600 rpm Flow rate: 30 m<sup>3</sup> / s. A slight increase in abrasion is to be expected within the new build.

In the course of a general refurbishment and performance increase of the pump, a new impeller was installed which changed the profile. This required a change in the contour of the shaft, which is where Belzona was required. The areas of the shaft in contact with water were coated with Belzona 5811.

The application was completed in accordance with Belzona System Leaflet MPT-01 and CEP-03.

Belzona 1311 (Ceramic R-Metal)  
Belzona 1321 (Ceramic S-Metal)  
Belzona 5811 (Immersion Grade)  
Belzona 9411 (Release Agent)
