# BELZONA PROVIDES PROTECTION FOR STATE-OWNED REFINERY TOWER

ID: 8240

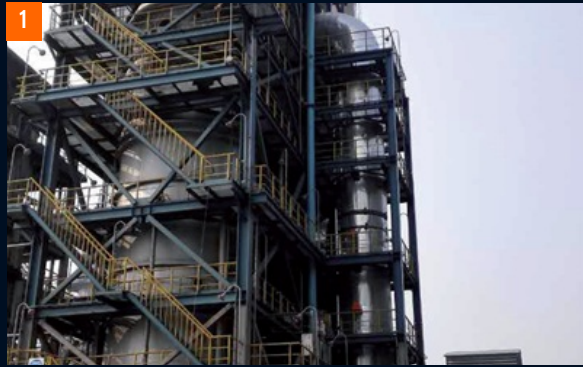
1. Refinery tower; 2. Failed original coating; 3. Coating application completed; 4. Coating remains intact after 1-year service

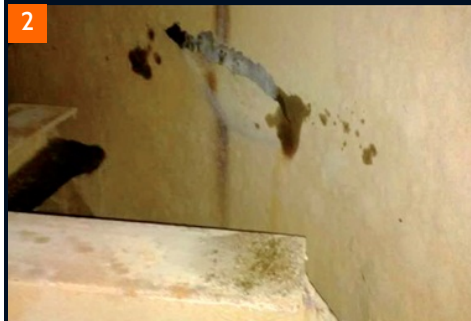
This complex tower in an oil refinery plant has been corroded by acid and alkali substances (such as  $H_2S$ ,  $SO_2$ ,  $H_2SO_3$ ,  $H_2SO_4$ ,  $NaOH$ ) for a long time, resulting in the failure and cracking of the original coating. The stainless steel bracket inside the tower also appears various degrees of corrosion.

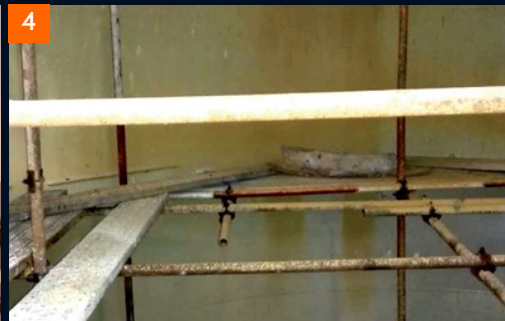
After Belzona coating has been in service for one year within an environment which contains acid and alkali substances ( $H_2S$ ,  $SO_2$ ,  $H_2SO_3$ ,  $NaOH$ ), according to on-site inspection, the overall surface of the inner coating looks very smooth, showing no leaking, shedding, bulging, cracking or other failure symptoms. Vessels protected with Belzona coating are easy to clean and able to continuously meet the requirements of anti-corrosion design and anti-corrosion protection requirements for the safe operation of the refinery.
