# BELZONA COMPOSITE REPAIR ON-SITE APPLICATION FOR BURIED NATURAL GAS PIPELINES

ID: 8242

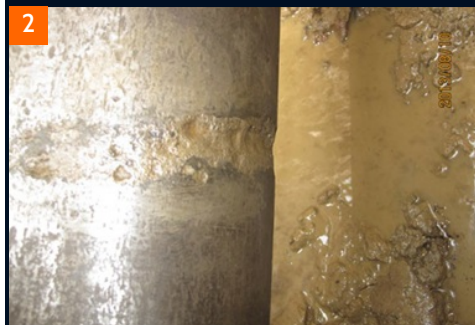
The operating pressure of these buried gas pipelines is 2Mpa; Maximum depth of external metal loss is 6.7mm; The corrosion area is 40 × 60mm. These pipelines have been immersed in a humid environment for a long time, and the surface of the pipeline cannot be dried.

1. Buried pipeline ;
2. Damaged external surface ;
3. Dry wrapping of the reinforcing sheet;
4. Application complete
