# BELZONA INTERNAL PIPE REFURBISHMENT TO INTAKE RELIEF VALVE TUBES

ID: 8243

Hydro Power Station, UK

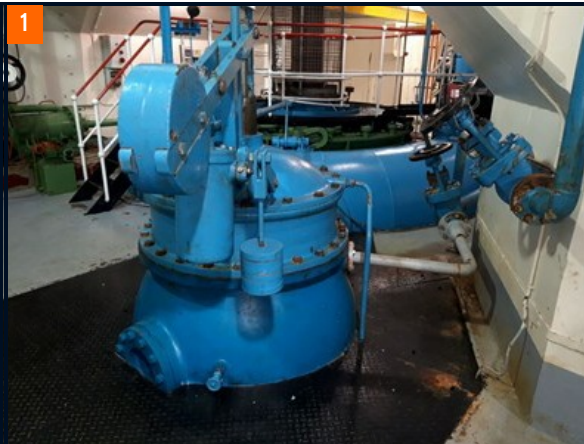
Each intake relief valve tube was leaking from a step between the tube and the valve causing water ingress to the interior area of the turbine hall. The tubes had been previously coated with Belzona 1321 around twenty years prior and unable to assess condition due to both being underwater.

1 – Intake Pipe Interior Turbine Hall

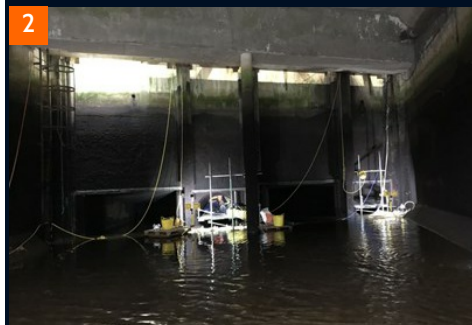
Belzona Protective coating in two separate valve chambers in submerged water service. The river water level had to be dropped by the temporary closure of up stream gate valves / sluices and to a level which allowed safe access to gain entry to the relief valve tubes.

2 – Two Underwater Intake Pipe Chamber Accesses

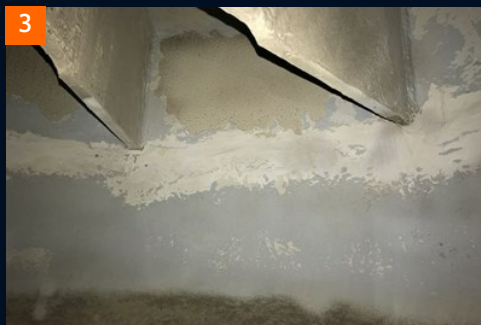
3 – Standard of Substrate Preparation

After dropping the water levels and drying the area, grit blasting to required areas was carried out in accordance with Belzona IFU. Belzona 1111 was applied in 45 degree fillets to prevent further leaks and seal off the internal areas, before applying Belzona 1321 as a two coat system to an area of 7.1sqm in accordance with VPF-02

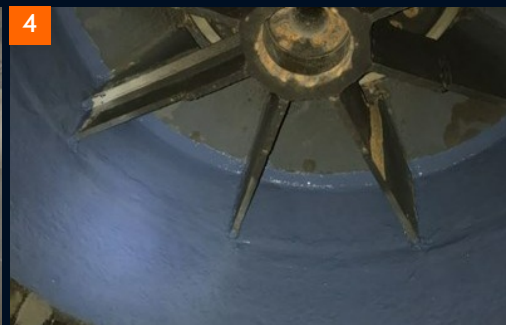
4 – Belzona 1321 Two Coat System Finished
