# BELZONA PROTECTS ICE BREAKER RESEARCH SHIP

## PROBLEM

An icebreaking polar supply and research ship returned to dry dock in South Africa for repairs after polar exploration.

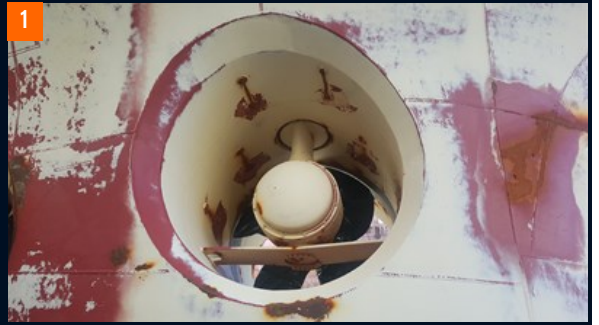
Areas and fixtures on the hull have been subjected to wear and erosion in service, leaving some of the steel exposed and open to corrosion.

1. Repair area prior to application
2. Detailed damaged area with steel loss
3. Coating application complete
4. Additional protection added to most severely affected areas

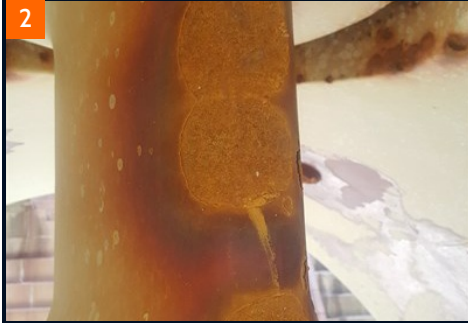
The original corrosion paint has proven to be not strong enough to handle the harsh sea ice conditions. Belzona was chosen due to its erosion resistance and durability, to prevent costly damage in the future, while steel loss was still minimal. 192 sqm was covered in total.
