# BELZONA APPLY PROTECTIVE TREATMENT TO NEW-BUILD PROPERTIES

ID: 8249

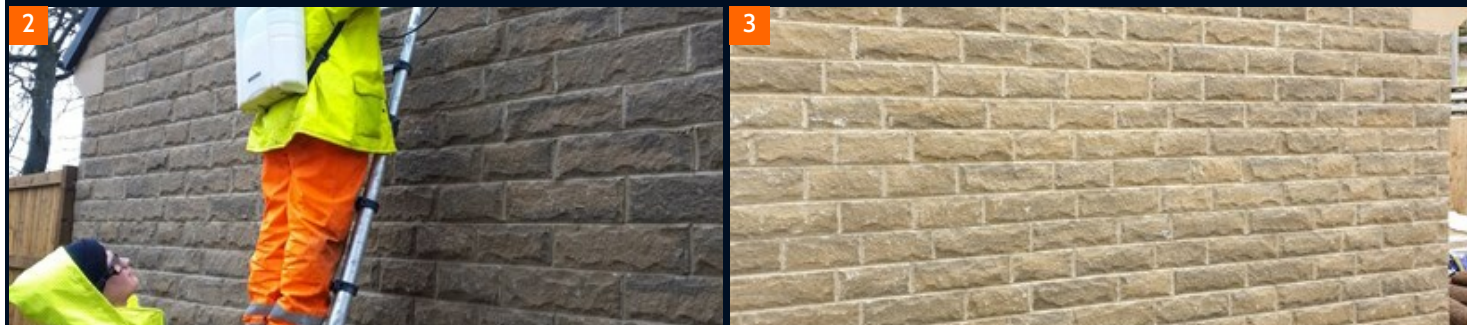
There was an unforeseen amount and severity of inclement weather in the area which had caused the garages to leak considerably.

The home builders had constructed the garages of a new housing development with only a single skin of bricks. There had been several high-level complaints from the homeowners on the issue. The client originally tried a competitor material to rectify the issues but in many cases this product was ineffective!

1. Garage wall to be treated
2. Application in progress
3. Application completed on one garage

Belzona 5122 was applied in accordance to Belzona Know-How System Leaflet WPA-8. Protective sheeting and tape was applied to all areas not being treated such as paths, plant life and windows near the application area. Belzona 5122 was then diluted at a ratio of 7:1 and put into a standard sprayer. Belzona 5122 solution was then sprayed onto the brickwork. Starting at the lowest part of the wall and applying upwards towards the highest section.
