# BELZONA SUPPORTS RUDDER BEARING TO NAVAL VESSEL

ID: 825

Rudder Bearing Housing

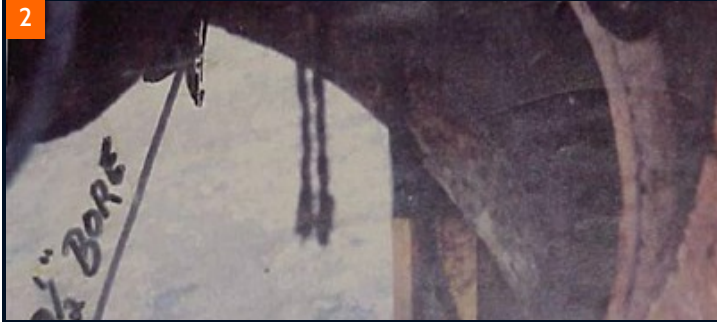
Fretting corrosion of the bearing housing

1. USS Detroit AOE-4.
2. 57 1/2" Port lower rudder bearing housing.
3. Housing re-machined.

The application was carried out in accordance with Belzona Know-How System Leaflet MPT-6.

The rudder stock running in this 57.5" diameter bearing weighs 62 tons and the displacement of the 26 knots fast combat support ship was 58,300 tons. The repair was in perfect condition at the last recorded inspection 17 years later (vessel is now decommissioned). Subsequently, in 1985 a sister ship had a similar repair.
