# BELZONA 5871 PROTECTS LOCAL PAPER MILL NCG HEADER PIPING

ID: 8250

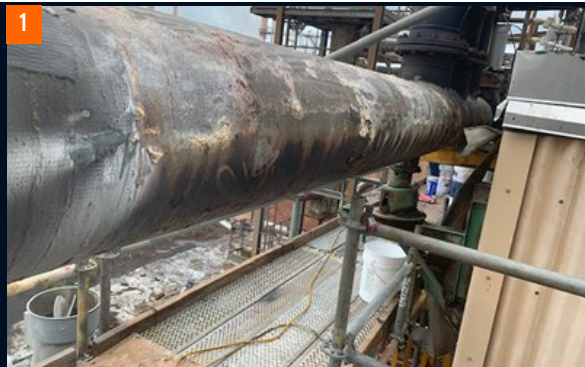
Some thin wall and through-wall defects (live leaks) were found on weld joints upon removal of the existing insulation.

Non-condensable gas header piping of dimensions 16 inch. OD and 100 ft. length and operating at 208 °F was suffering from corrosion under insulation.

1. Corroded pipe condition after insulation removal
2. Surface preparation
3. Temperature reduction on the pipe after 5871 application
4. Insulated piping

Wall thickness readings were taken prior to any work being completed. Belzona 1511 was used to rebuild thin wall defective areas prior to the application of Belzona 5871. Due to non-sparking requirements onsite, the substrate was prepared using MBX bristle blaster and wire brushing.
