# SEALING A TRANSFORMER USING BELZONA

ID: 8251

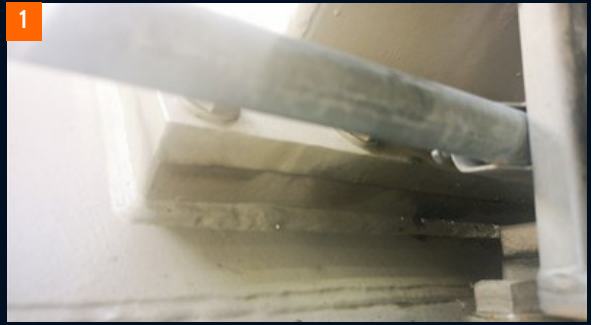
Various places from which oil has escaped due to a defective seal.

1. Assessment of the leak places
2. Machine grinding and cleaning the surface, and seal with Belzona 1212
3. Connection and screw heads with Belzona 1161
4. Screws and connection with Belzona 5831 seal
