# BELZONA RESTORES RUDDER STOCK TO ORIGINAL DIMENSIONS

ID: 826

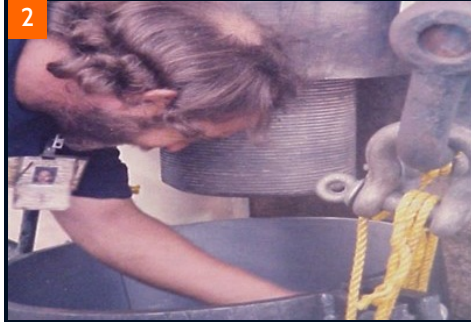
Corrosion of port and starboard rudder stock seals, resulting in 1/4" (6mm) metal loss on the diameter

1. Seal area suffering from corrosion.
2. Application of release agent to former.
3. Split sleeves in place.
4. Completed application.
