# BELZONA RESTORES A TANK ROOF IN HUNGARY

ID: 8260

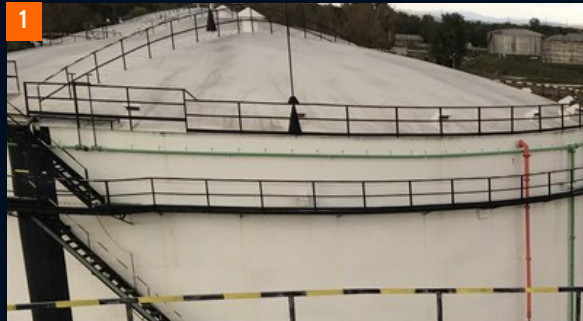
The tanks roofs were heavily polluted with a dirty grayed appearance generating higher temperature and so more evaporation of high volatile fuel in the summer period. This is a huge loss of product for the asset owner.

The Oil refinery were looking to reduce liquid temperatures in the tanks, the current tanks roofs were very dark and grey and were not reflecting the light sufficiently.

1. Polluted tank roof (before)
2. Belzona 6111 Liquid Anode used as a primer on the blasted surface.
3. Belzona 5111 Ceramic Cladding White was sprayed.
4. Condition check after 4 years. No problem, perfect performance.
