# BELZONA SEALS AND REINFORCED GAS PIPELINE GULENG CHEMICAL PLANT

ID: 8262

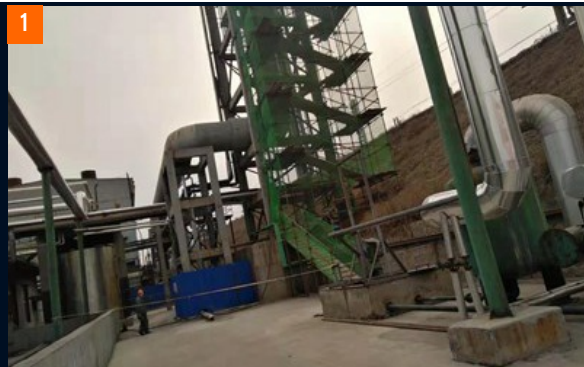
1. Application site overview
2. Corroded pipeline
3. Leakage repaired
4. Application complete

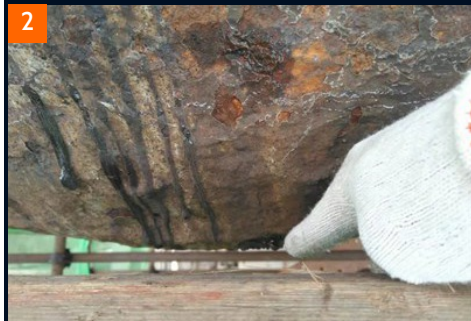
Due to the long-term contact of the gas pipeline with the harsh environment inside and outside (As the gas is transported for a long distance, the temperature continues to decrease, and the water vapor in the gas condenses. The salty substances in the gas dissolve in the condensed water to form an aqueous solution with higher salt content; There are corrosive compounds in the gas, which dissolve in water and chemically react with the metal on the inner wall. Acidic substances dissolve in the condensed water, resulting in acid corrosion due to the low pH value. Then, under the action of the physical erosion of dust, it brings serious harm to the pipeline.), the gas pipeline has suffered from thinning walls and pitting after long-term operation. There are 4 leaking spots in the gas pipeline, which leads to potential safety hazards. It is necessary for an urgent on-site application to seal reinforce the gas pipeline.
