# BELZONA REPAIRS AND PROTECTS CENTRIFUGAL PUMP

ID: 8266

Centrifugal Pump casing and discharge mouth at a sugar plant in Pune Region

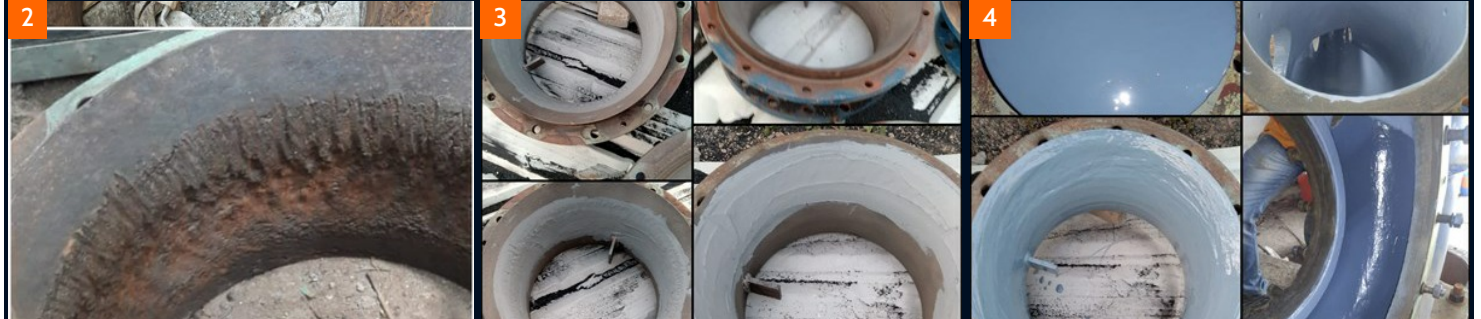
Feed water at max. 45 deg C was pumped through these pumps for the sugar processing plant. Due to design fault, there was lot of turbulence at discharge which resulted in heavy erosion and corrosion of discharge mouth. They had to replace that part every year. The customer needed a solution that could extend the life as well as be within their budget.

- 1) Pumps at the time of inspection
- 2) High erosion on mouth
- 3) Metal rebuilding done with Belzona 1111
- 4) Coating completed

Grit blasting done to prepare the surface to 75 micron profile and SA 2.5 cleanliness. Belzona 1111 used to rebuild the surface. Two coats of Belzona 5821 applied to the pump.

SOP demands use of Belzona 1321 Ceramic S-Metal as the protection coating as it provides a good erosion corrosion resistance. However, client budget was limited, and Cost of application with Belzona 1321 was making it difficult for finalizing the project. Newly launched Belzona 5821 was projected as solution and it performed well over last 2 seasons of Sugar crushing. The cost of application was half of that with Belzona 1321 Ceramic S-Metal.
