# BELZONA REPAIRS AND PROTECTS 18 CHILLERS

ID: 8267

Tubesheet and Water boxes of Chiller units

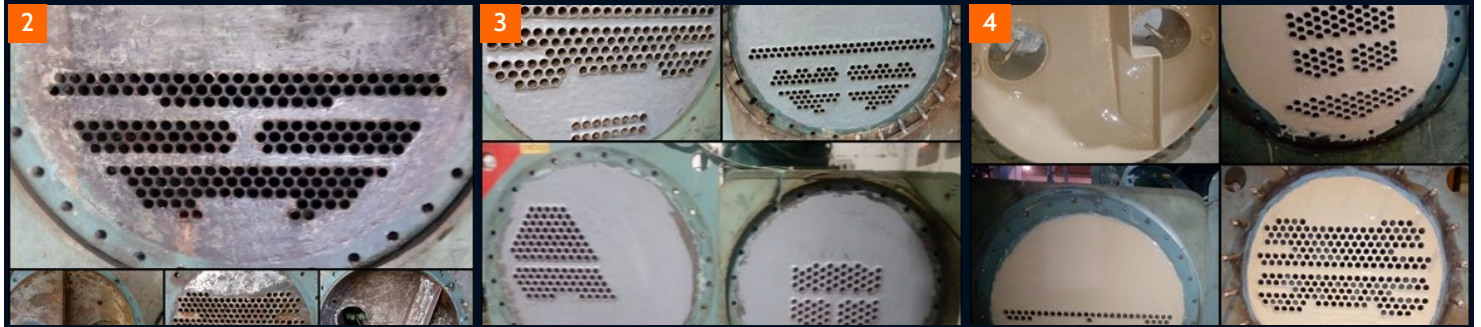
Tubesheet and water box surfaces of 10 Chillers of a Plastic Plant's HVAC system were corroded over time. The client had purchased 8 new chillers for a new HVAC system and had planned to replace the 10 chillers in phases. Customer needed a cost effective solution.

1. Old Chiller with tubesheet and water boxes
2. Chiller under process of being cleaned
3. Chiller resurfaced with Belzona 1111
4. Chiller coated with Belzona 5811

Application carried out in accordance with Belzona Know-How System Leaflets HEX-1 & -3. After corking tubes, Belzona® 1111 used to ensure the tubes are flush with the surface before applying the Belzona 5811 system.
