# BELZONA KEEPS DECKING SAFE

ID: 827

Grooved timber decking

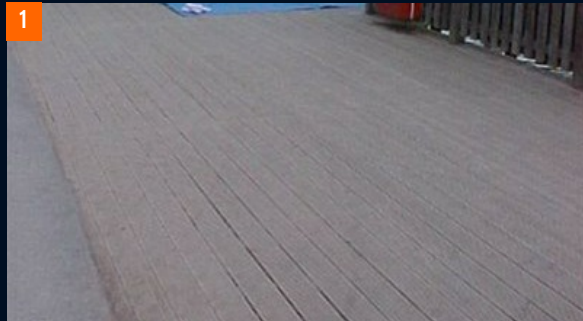
Slipping hazard, particularly when wet. Also wear on top surface.

1. Slippage problem area.
2. Belzona grip system was mixed and piped using polyethylene bag, and then spread with an applicator. Further aggregate was then spread over the area.
3. Completed application.
