# BELZONA KEEPS ENTRANCE WAY NICE AND SAFE

Timber Decking

Theme Centre, Doncaster, UK

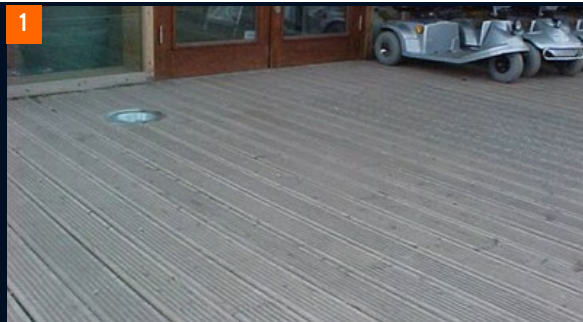
Slippage problem, especially on the main entrance of the building. The client had tried unsuccessfully to combat the problem by nailing chicken wire to the timber decking, which caused extra trip hazards.

1. Slippage problem area.
2. After masking 2 out of 6 grooves, Belzona 5811 was mixed with 50% aggregate applied.
3. Masking being removed from completed application.

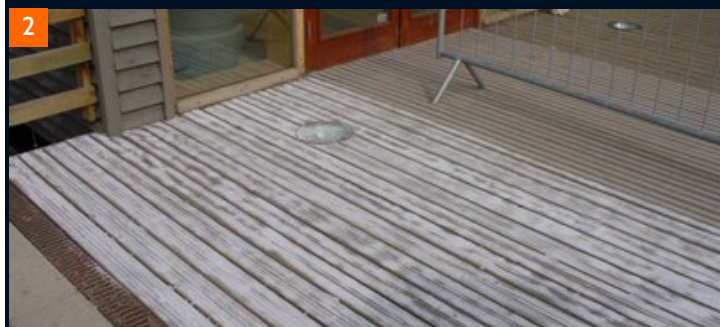
The application was carried out using a modified version of the Belzona Know-How System Leaflet FPA-8. The Belzona® 5811 was mixed with 50% of Belzona® 9221.
