# BELZONA REFURBISHES OLD WEATHERED INDUSTRIAL ROOF

ID: 8280

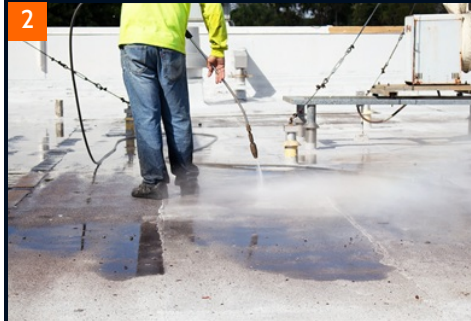
Numerous water leaks and deteriorated roof

The raining season was about to begin and this roof had several leaks and deteriorated areas that were potentially going to become problematic

1. Roof before product application
2. Surface preparation via pressure cleaning
3. Mesh being applied over joint
4. The finished area

Application was carried out in accordance with Belzona Know-How System Leaflets RPA-1 and RPA-8. Surface was cleaned via pressure washing. Belzona 3911 was applied with a brush as a primer over the entire roof and belzona 3921 was applied over any metallic substrate. Belzona 3111 was spray applied over the horizontal surfaces and brush applied over seams and difficult geometries. Belzona 9311 sheet was additionally applied to problem areas such as joints, seams and glazing bars as additional reinforcement.
