# BELZONA SEALING OF DRAIN OUTLETS ON ENGINEERING WORKSHOP ROOF

ID: 8284

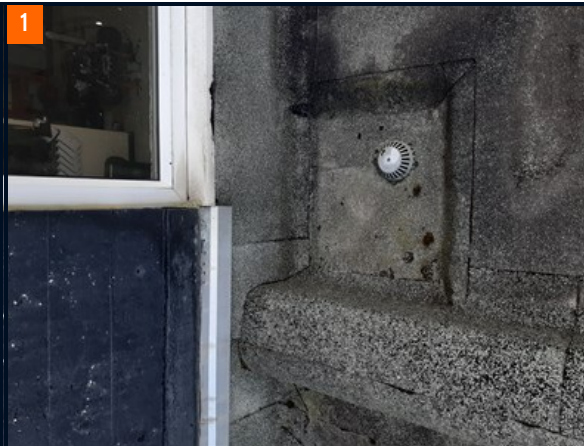
The roof had been suffering from water ingress from its roof top drain outlets.

1. Example of prepared area ready for repair
2. Completed application
3. Completed application

The application was carried out in accordance with Belzona Know-How System Leaflet RPA-8. The leaking areas were cleaned down using a wire brush. The repair areas were then taped up to ensure an aesthetically pleasing finish. A first coat of Belzona 3131 was applied incorporating Belzona 9351 reinforcing sheet. As soon as the first coat was cured a second coat was applied to each area and the tape was removed.
