# BELZONA REPAIRS LEAKING ROOF AT UNIVERSITY

ID: 8285

University canteen roof.

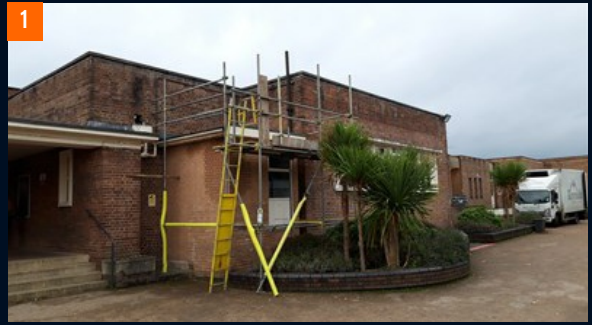
A small felt roof over a section of the canteen was in need of repair. The felt system had degraded to the point where rainwater is now entering the building.

1. University canteen roof ready for repair
2. Surface preparation in progress
3. Application of Belzona 3131 in progress
4. Completed application
