# BELZONA 5871 PROTECTS STEAM PIPING HAZARDOUS TO OPERATORS

ID: 8288

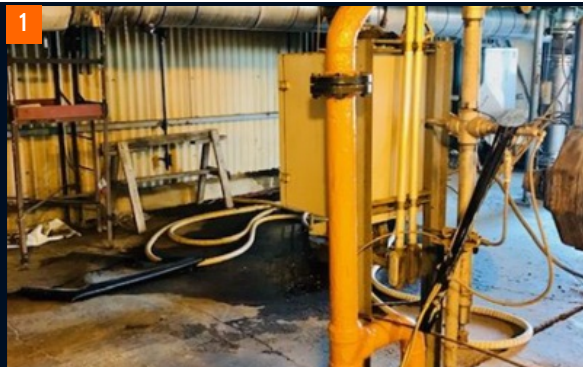
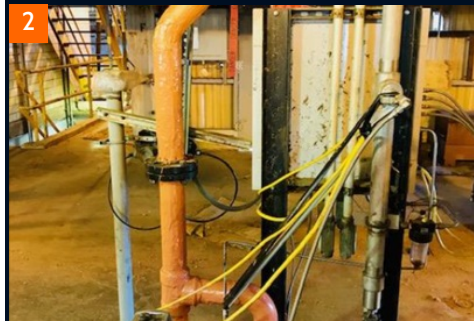
1. Pipe coated with Belzona 5871
2. Pipe coated with Belzona 5871
3. Measuring temperature after application of Belzona 5871
4. Measuring temperature after application of Belzona 5871

The line was shut down for safety handling during application procedure. Belzona 5871 was applied in 4 coats in one day, with a total DFT of 160-180 mils.

The curing time of Belzona 5871 was accelerated because the pipe was still warm during application. All 4 layers of Belzona 5871 were applied in one day, and 4 more identical pipe sections were repaired during a planned maintenance. Belzona was able to reduce the temperature down to 110F, preventing any type of contact surface burn and protecting the pipe against future corrosion degradation.
