# BELZONA SAVES ROTOR AND MAINTAIN PRODUCTION

Rotor of Water Ring Vacuum Pump

Carton Plant - Jordan

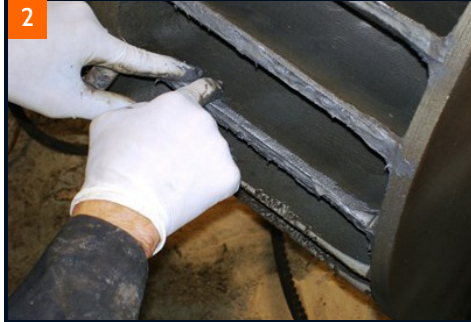
Severely eroded, no replacement available. New Rotor would cost \$11,000 USD.

1. Main body of rotor severely eroded
2. Rebuilding and reinforcing with Belzona 1111
3. Top coating with Belzona 1321
4. Ready to be in operation
