# BELZONA RESTORES AND PROTECTS JET TUBES FROM EROSION

ID: 8290

High Speed Passenger Ferry Jet Tubes

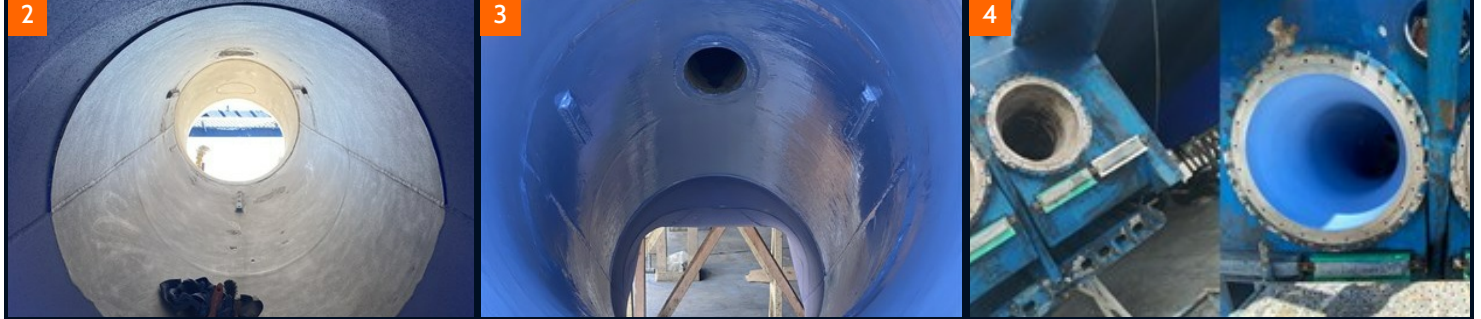
The 4 Jet Tubes presented severe pitting and cracking, due to erosion and cavitation. This existing paint system has failed locally, leading to metal loss and cracks.

1. Initial State Of Jet Tubes
2. Jet Tubes Blasted to Sa 2,5
3. Belzona 1341 Applied
4. Jet Tubes Before and After Application of Belzona System

Application is carried out in accordance with Belzona Know-How System Leaflets SOS-1 & 2. Surface was prepared according to ISO 8501-1 Sa 2,5. All the areas suffering from pitting, cracking and metal loss, were rebuilt with Belzona 1311. Finally, two coats of Belzona 1341 were applied to the whole internal surface of the Jet Tubes, in order to provide erosion protection & water flow optimisation.
