# LEAKING WELDS ON DIESEL TANK NO PROBLEM FOR BELZONA

Diesel tank on a ship, which has docked for a short period for repairs.

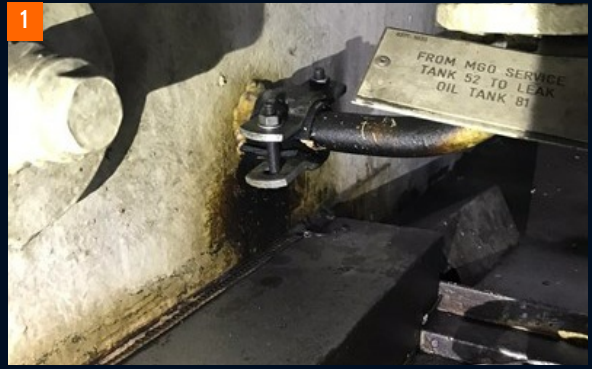
Welds connecting the diesel tank to one of the pipes has degraded. Previous attempts had been made to seal leaks around the weld, by adding further weld material, leaving a messy weld area, and failing to solve the issue long term. Subsequently, a clamp was used as a temporary measure to reduce the leak, however this could not stop the leak due to the geometry of the pipe / tank connection.

1. Temporary clamp repair in place
2. Repair area with clamp removed
3. Repair area after surface preparation
4. Completed repair
