# BELZONA BONDS PLATES WITH MAGNET CONSTRUCTION SUPPORT.

ID: 8293

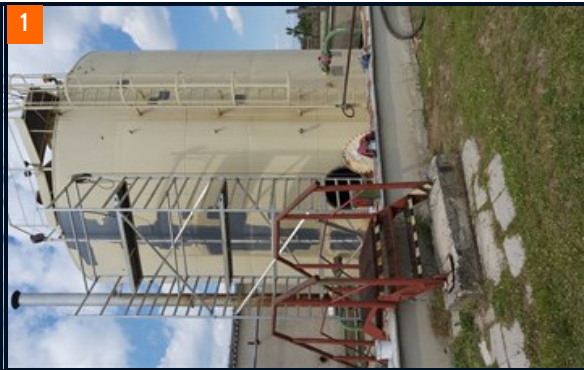
The tank was damaged by corrosion from aggressive residual water at crude oil production process. Because the customer needed very quickly repair he made decision to repair only damaged parts of the tank.

1. Tank was damaged by corrosion from aggressive residual water
2. Chemical corrosion leads to tank wall damage
3. Belzona 1111 was applied directly onto the prepared surface
4. Magnet construction keeps plate on the right place with sufficient pressure.

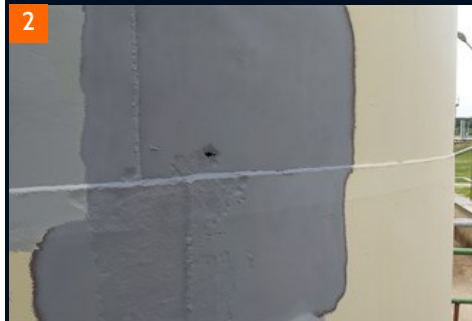
Chemical corrosion leads to tank wall damage.
