# BELZONA REPAIRS CAVITATION DAMAGE ON CARGO SHIP

ID: 8298

High cavitation damage under the stern flange of the propeller shaft

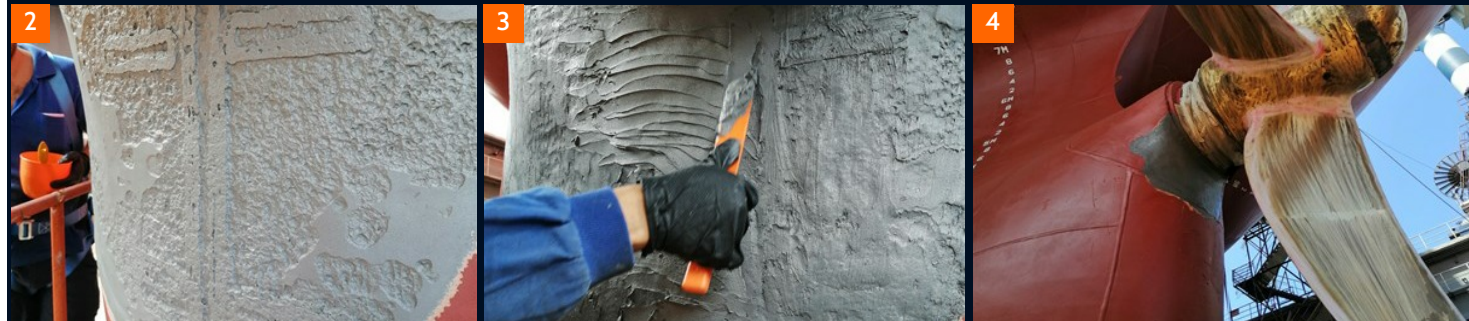
## PHOTOS

1. Cavitation damage surface
2. After surface preparation
3. Application of Belzona 1311
4. After Belzona application

Application was carried out in accordance with Belzona Know-How system Leaflet SOS-01. Application surface prepared with grit blasting to achieve SA2½. Surface then cleaned with Belzona 9111. Belzona 1311 was used to repair the damaged surface.
