# BELZONA 1811 KEEPS THE MILLS WORKING

ID: 83

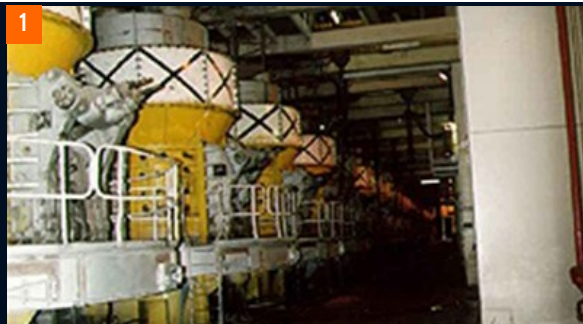
1. General view of the coal mills
2. Application of Belzona 1811 being undertaken in the confined spaces
3. The completed application with Belzona 1811 used to restore original profiles in localised erosion areas
