# BELZONA SAFEGUARDS BOTTLING PLANT

ID: 830

Bottling ring 2.7 meters diameter severely eroded and corroded.

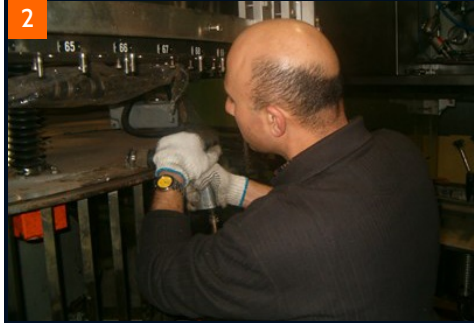
Extensive deep pittings and corrosion all over the large ring led to loss of pressure.

1. Damaged ring
2. Surface preparation
3. Filling, forming, and coating completed
4. Back in operation after two days
