# FAIRLEADS ASSEMBLY WITH BELZONA

ID: 8300

Yacht with aluminum body

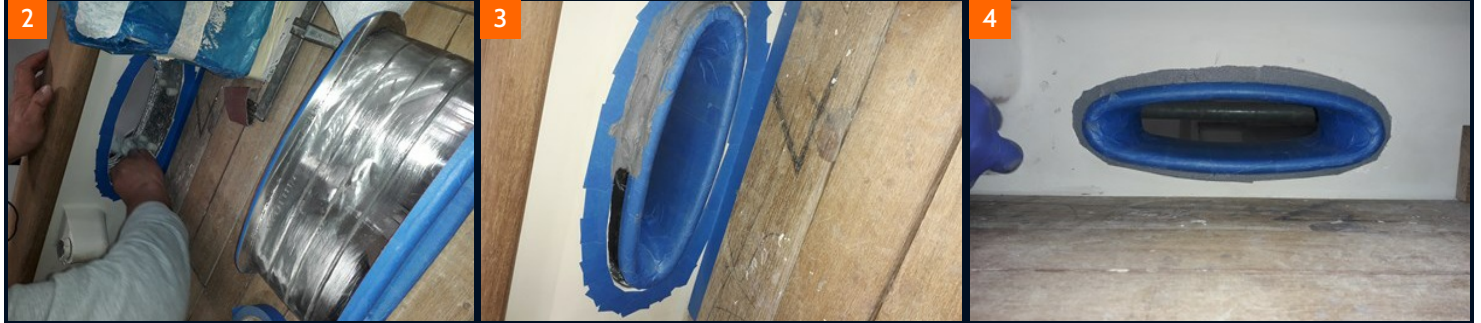
Conventional methods of installation fairleads result in voids between the fairlead and housing. Bi-metallic corrosion may occur between aluminum body and stainless steel equipment used.

1. Before application
2. After surface preparation
3. Application of Belzona
4. After Belzona application

Application was carried out in accordance with Belzona Know-How System Leaflet SOS-08. Application surfaces was prepared to achieve SA2½ cleanliness. Aluminum housing inner surface and stainless steel fairlead exterior surfaces cleaned. The fairlead is aligned to the aluminum housing mechanically. Sealing and assembly was done with Belzona 1111. The void in the fairlead pocket was filled with Belzona 5811 by injection method.
