# BELZONA 1381 TANK PROTECTION

ID: 8301

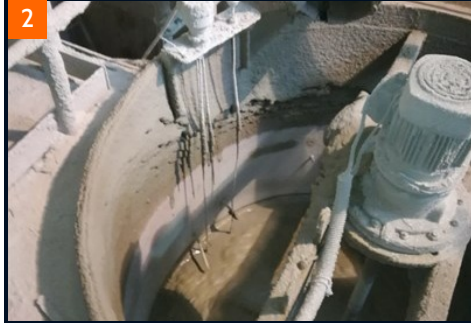
1. Two tanks are bigger
2. Fluid flow mix
3. Tank was blasted and cleaned
4. Second layer of Belzona 1381

These tanks were blasted and cleaned. Two coats of Belzona 1381 were applied by spraying. The application was done in accordance with Belzona System Leaflet TCC-5.
