# BELZONA PROTECTS A FLOOR OF A LEADING EUROPEAN COMPANY.

ID: 8303

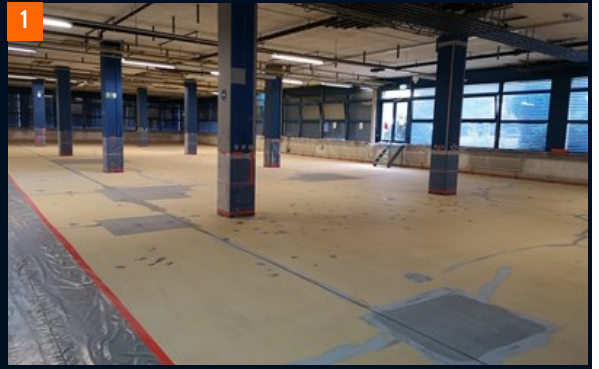
1. Floor Preparation
2. Airless Spraying of Belzona 5811
3. Close up of incorporated aggregate
4. Complete Job

The concrete substrate was abraded to expose the aggregate, the surface was sprayed with Belzona 5811 using airless spraying equipment in accordance with Belzona System Leaflet FPA-3. The expansion joints were filled using Belzona 4521 in accordance with Belzona System Leaflet FPA-6
