# BELZONA SUPERWRAP II PATCH REPAIR ON TANK

ID: 8304

Restoration of a tank external using several composite SuperWrap II patches.

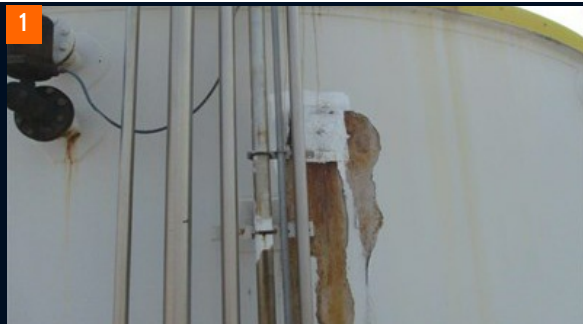
External corrosion on the exterior of a tank causing a loss in material substrate.

1. Defect zone
2. Up close of the defect zone
3. After mechanical preparation
4. Final application
