# PAVING SLAB WALKWAY REPAIR WITH BELZONA

ID: 8305

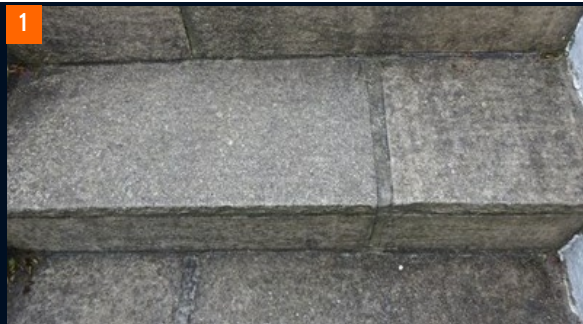
Marshall's paving slabs had been installed on a domestic walkway as step treads. These slabs had started to deteriorate through wear, age & weathering. The slabs had lost their original colour & now had a dull appearance. The slabs were then replaced at the expense of the installer but after a further six years the replacements had also deteriorated. A permanent solution was required.

1. Paving slabs original
2. Wear & weathering of the existing slabs
3. Belzona 4111 colour matched & applied
