# BELZONA SAVES PLANT \$400,000 PER WEEK

## PROBLEM

Air intrusion into ductwork seriously affected plant efficiency

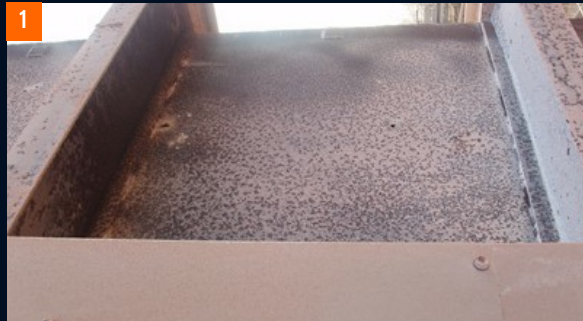
The steel ductwork had become corroded from salt water spray and NaOH mist. Vibrations from operations caused sections to become disbonded from the framework.

1. Ductwork before work commenced
2. Close up of framework showing loose connections
3. Another view of framework showing loose connections
4. Finished application

Application carried out in accordance with Belzona Know-How System Leaflet TCC-5. Belzona® 1111 and 1121 were used to bond loose metal to framework when system was out of service and cool. System was then brought up to operating temperature and Belzona® 5851 was used to coat the repaired areas and the entire surface to prevent further corrosion.
