# PUMP REPAIR AND PROTECTION WITH BELZONA 1814

ID: 8313

Rebuilding and protecting a pump for a shipyard.

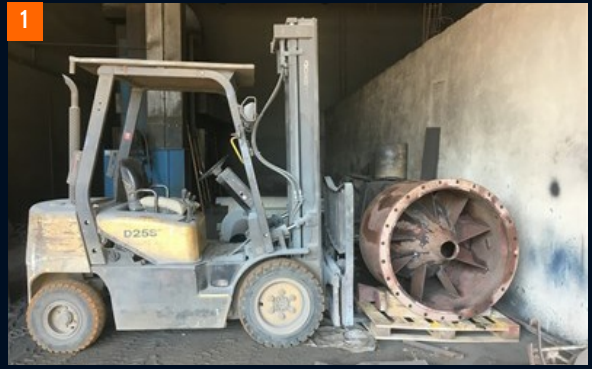
The pump was suffering from corrosion and also abrasion/erosion from the entrained solids within the process, this was causing a loss in pump efficiency.

1. Before application
2. Rebuilding body of the pump with Belzona 1814
3. Rebuilding pump vanes with Belzona 1814, other sections rebuilt with Belzona 1311
4. Final application - 2 coats of Belzona 1321

The application was carried out in accordance with Belzona Know-How System Leaflet SHM-11. The whole interior and exterior of the pump was grit blasted to SA 2.5. Once grit blasted, the vanes and the center section of the pump were applied with Belzona 1814 as these area was where the most severe abrasion/erosion was occurring. The other less severe areas were rebuilt with Belzona 1311. Once the rebuilding with Belzona 1814 & 1311 was done the whole interior section of the pump was coated with 2 coats of Belzona 1321 for added erosion and corrosion protection.
