# BELZONA REPAIRS SCREW FEED TROUGH

Restoration of a screw feed trough used for waste management.

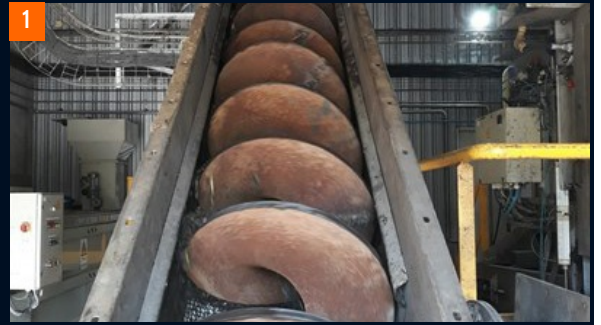
This screw conveyor was used for the movement and separation of media such as glass, plastics and general waste for a landfill site. The harsh media going through the screw conveyor was causing severe abrasion on the screw feed trough leading to regular cracks and repairs through welding, this meant massive regular downtime for the client and they wanted to find a long term solution.

1. Before application - Previous 1.5m trial section can be seen at the bottom of the feed
2. Close up of the 1.5m trial patch after 6 months in service
3. Start of preparation and application of the Belzona 1814 section
4. Final application

This application was carried out in accordance with a modified version of system leaflet SMH-07. The surface of the screw feed trough was prepared and cleaned before the top section of the trough was applied with Belzona 1814, the majority of the trough was then applied with Belzona 1811. The Belzona 9811 alumina tiles were also incorporated with the Belzona 1811 and Belzona 1814 to create a high abrasion resistant system.

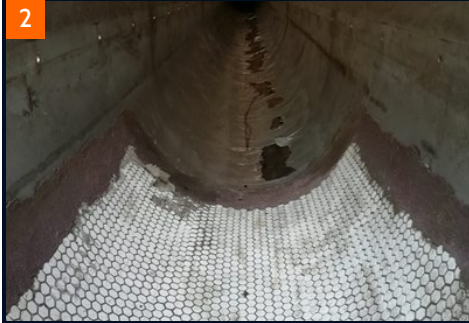
It was agreed a 1.5m trial application would be carried out before the whole screw conveyor was to be repaired as this was the client's first time using Belzona. 6 months after the original trial the results showed the Belzona system to still be in excellent service condition. The client was extremely happy with the results and agreed to proceed with the whole screw conveyor. To follow the strict time scale the whole application was carried out in 2 days and a total of 180Kg of Belzona 1811 and 1814 was used.
