# BELZONA PROTECTS PHARMACEUTICAL PLANT FLOOR

ID: 8317

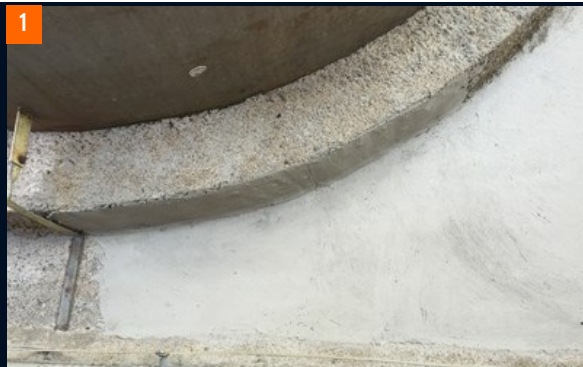
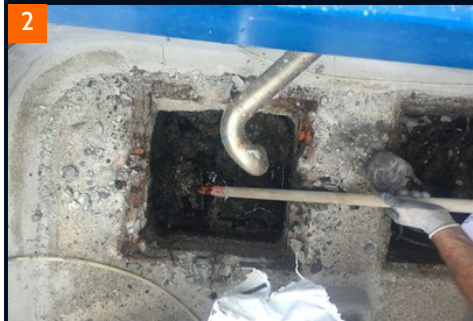
This plant floor and sump area were located outside and the outdoor roof didn't cover the full area, this was causing the concrete to degrade over time. Also, due to process there was occasional chemical spillages onto the concrete and therefore the client wanted the concrete sealing.

1. Before application
2. Before application
3. Final application
4. Final application

This application was carried out in accordance with system leaflet FPA-03. The concrete floor was prepared through grinding and cleaned before applying the Belzona 5231 with rollers.

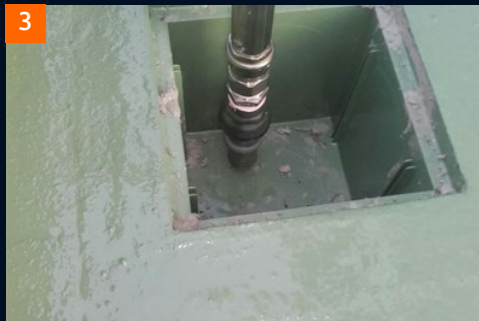
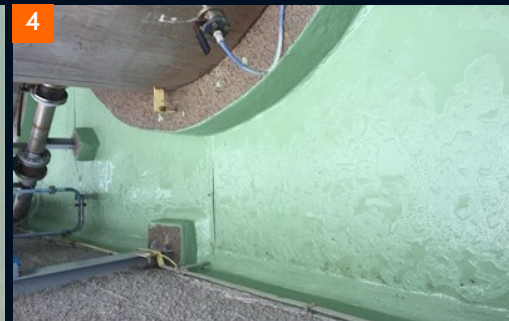
Installation of a new positive grip flooring system on an outdoor concrete floor.
