# BELZONA UPGRADES PLANT ROOM FLOOR

ID: 8318

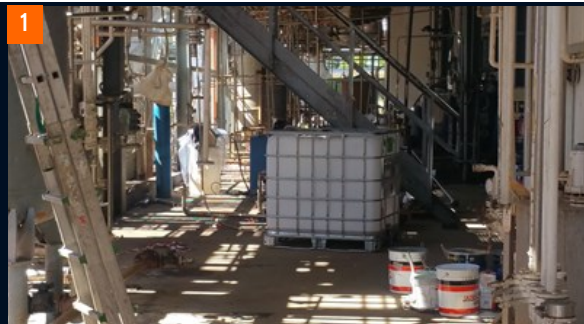
1. Before application - Extension of plant room
2. Before application
3. Belzona 5231 being applied by rollers
4. Final application
