# PHARMACEUTICAL COMPANY SELECTS BELZONA 4181

ID: 8319

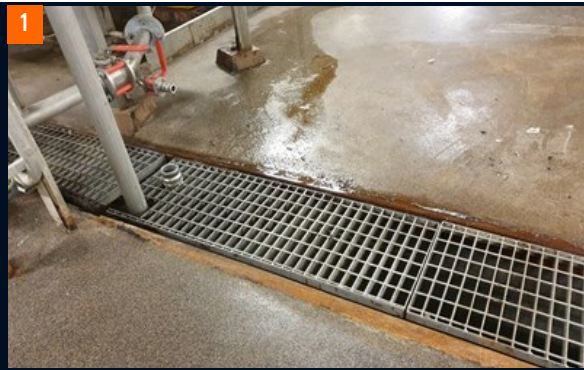
The historic flooring had insufficient gradient for the chemicals to lead into the channels therefore the chemicals were pooling on the floor close to the channel, the old channels had weld seams which was causing leaks. This year the client needed to repair the drain-channels in the process basement and the distillery. There were two different problems. Problem One: The old factory (to be taken out of production in a couple of years), the flooring around the channel was deteriorated and uneven, and caused chemical waste to be lying still, without running down in the channel for transportation to the waste treatment process. Problem Two: The distillery area, waste channels needed a coating, due to weld seams that had cracking. The client requested the bottom of the whole channel to be coated, and also the sides.

1. Problem of chemical sitting on the floor area
2. Application of Belzona 4181 complete
3. Waste Chemical Channel deteriorated.
4. Waste Channel Repaired with Belzona 4181
