# BELZONA ELASTOMERS IDEAL FOR HIGHWAY REPAIRS

ID: 832

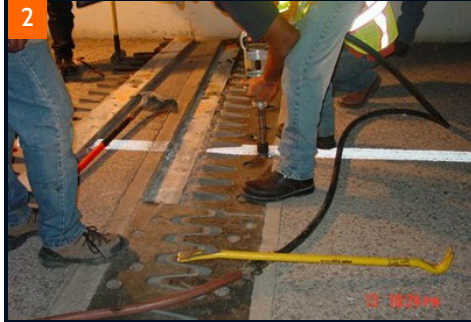
1. Large highway expansion joint
2. Grate over sealant removed
3. Torn rubber was cleaned, roughed up and conditioned
4. Finished repair

Application carried out using modified version of Belzona Know-How System Leaflet SHM-9. Areas were cleaned and roughened up using the Belzona roughing brush. Belzona® 2911 was applied and followed by Belzona® 2311.
